ERDC/GSL TR-01-7

## **Expedient Road Construction Over Soft Soils**

May 2001

Final report

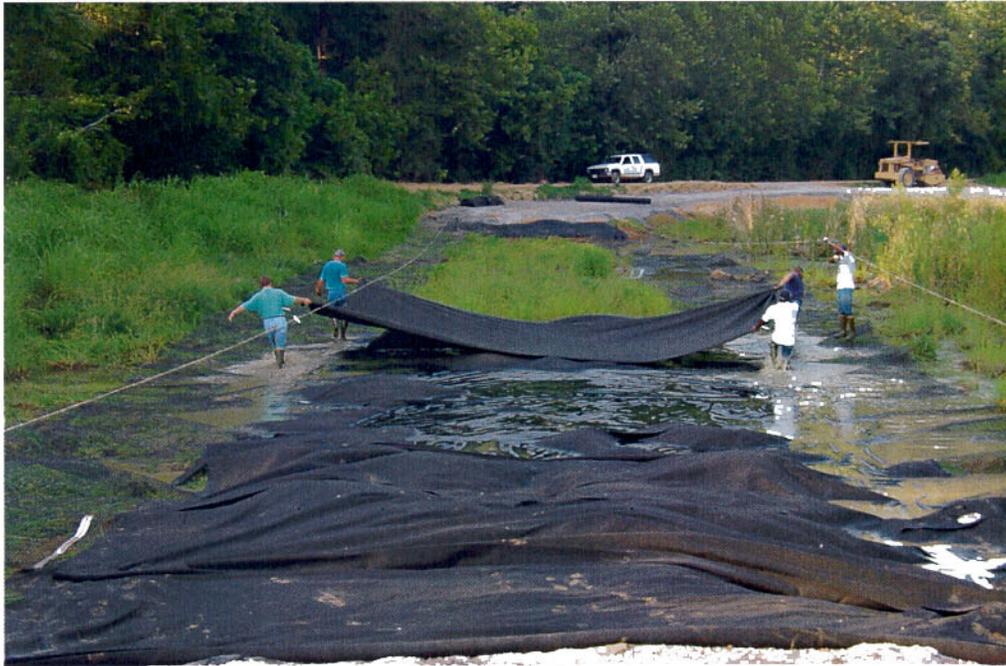
Photo 6. Installation of geotextile on roadway

The nonwoven needle-punched geotextiles used in this research were produced by LINQ Industrial Fabrics and Contech Construction Products, Inc. These geotextiles were used to prevent the pumping of subgrade fines into the structural layers (i.e., mats, wood chips, sand, and crushed limestone) because of the soft soil conditions and heavy truck traffic. The properties of C-80NW and 180EX geotextiles are presented in Table 3 (GFR 1998). The material was supplied in rolls, each containing a sheet of geotextile 15 ft wide and 300 ft long. The cost of test quantities of the C-80NW and 180EX were both \$0.07/ft<sup>2</sup>. Photo 6 shows the actual installation of geotextile on a roadway.

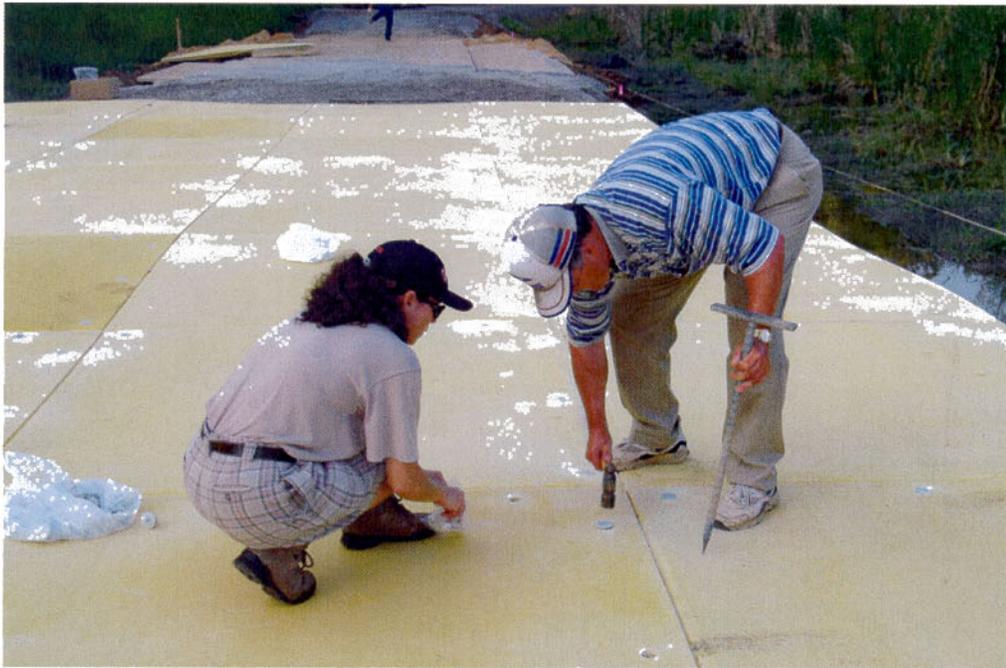
Photo 17. Installing connector pin to connect fiberglass panels

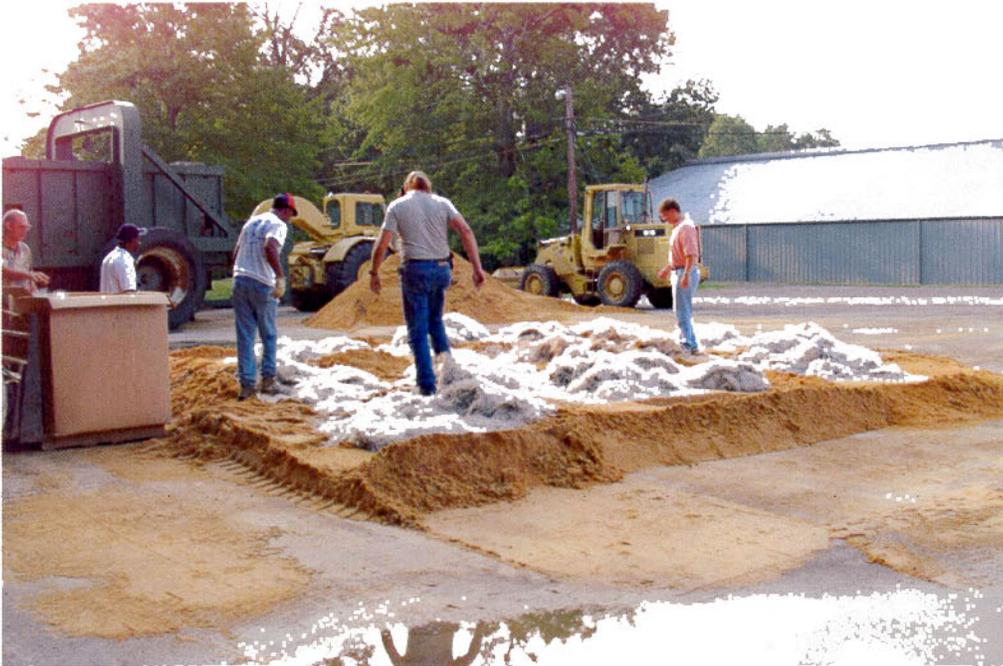
Photo 26. Fibers spread over moist sand

The sand described previously was reinforced with small amounts (0.8 percent by dry weight of sand) of hair-like 2-in.-long monofilament fibers. The fibers were mixed into moist sand using a self-propelled rotary mixer. These 2-in. polypropylene fibers have a specific gravity of 0.061 lb/ft, a tensile strength of 75,000 psi, and a Young's modulus of 500,000 psi. The 20-denier monofilament fibers were used in this investigation. A denier is the mass in grams of a 27,528-ft length of a fiber, and it is used as a measure of fineness as developed by the textile industry. The sand-fiber mix can withstand an unconfined compressive strength of 21 to 27 psi for a 0.5- and 1-in. deformation, respectively. The cost of the fiber is \$1.60 per pound (Tingle, Webster, and Santoni 1999 and Webster and Santoni 1997).

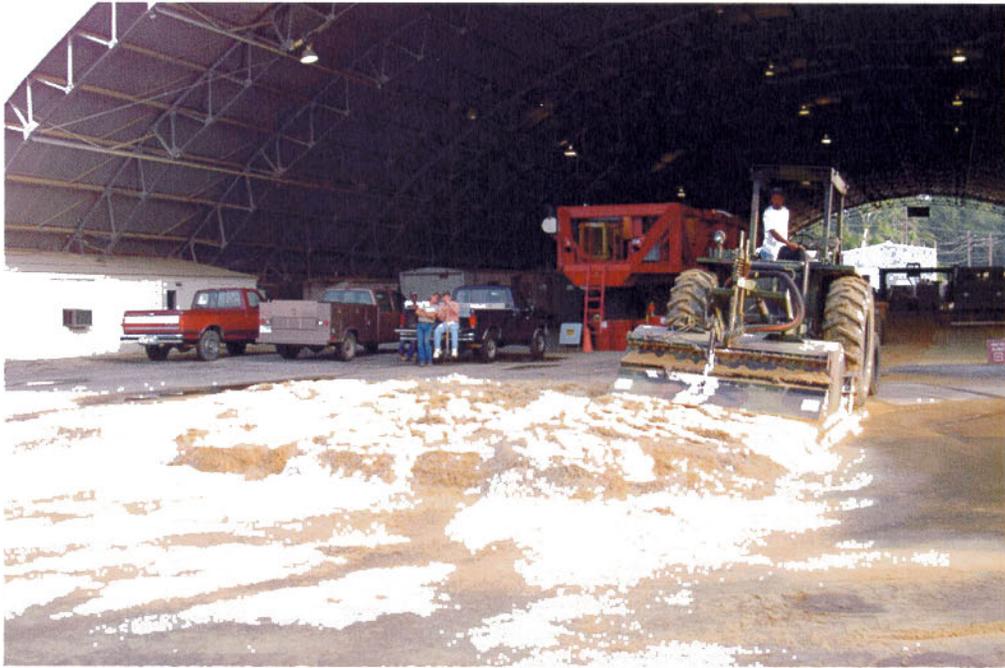
Photo 27. Fibers mixed with sand using a self-propelled rotary mixer

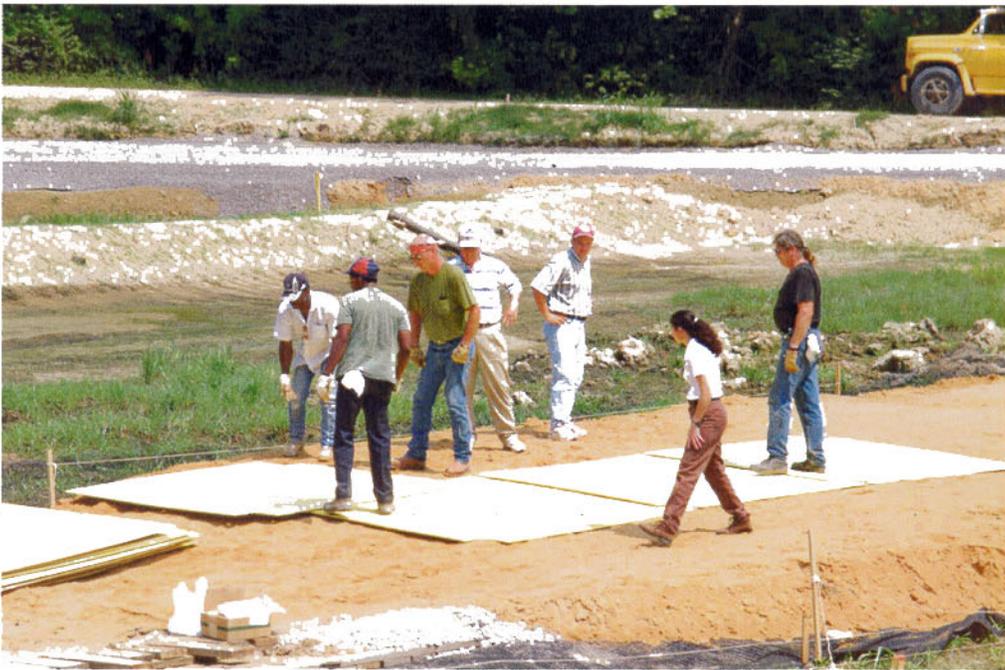
Photo 28. Placement of fiberglass-reinforced panels on Item 3

**Fiberglass-reinforced mat.** The initial design of the 4- by 12-ft fiberglass-reinforced mat was based on a mat developed by the U.S. Air Force under its rapid runway repair project. Based on field investigations, the mat size was redesigned at ERDC to improve its installation rate. The new mat panel was 6 ft, 8 in. by 6 ft, 8 in. by approximately 0.35 in. thick. The usable surface area when installed is approximately 36 ft<sup>2</sup>. The mat consists of a polyester resin reinforced with four plies of woven chopped fiberglass. The polyester resin-to-fiberglass ratio was approximately 11:9 by weight. The weight of a panel was approximately 115 lb or 2.59 psf. During installation, the panels were connected by using "pop-in-pop-out" pin connectors. Figure 1 shows the dimensions of the fiberglass mat panels. The material cost of the assembled matting was \$9.92 per sq ft. The fiberglass-reinforced mat was fabricated by GFI, Inc., Harrison, AR. Photos 1 through 64 depict the general construction of a beach roadway surfacing system. Photo 28 shows the actual fiberglass-reinforced mat.

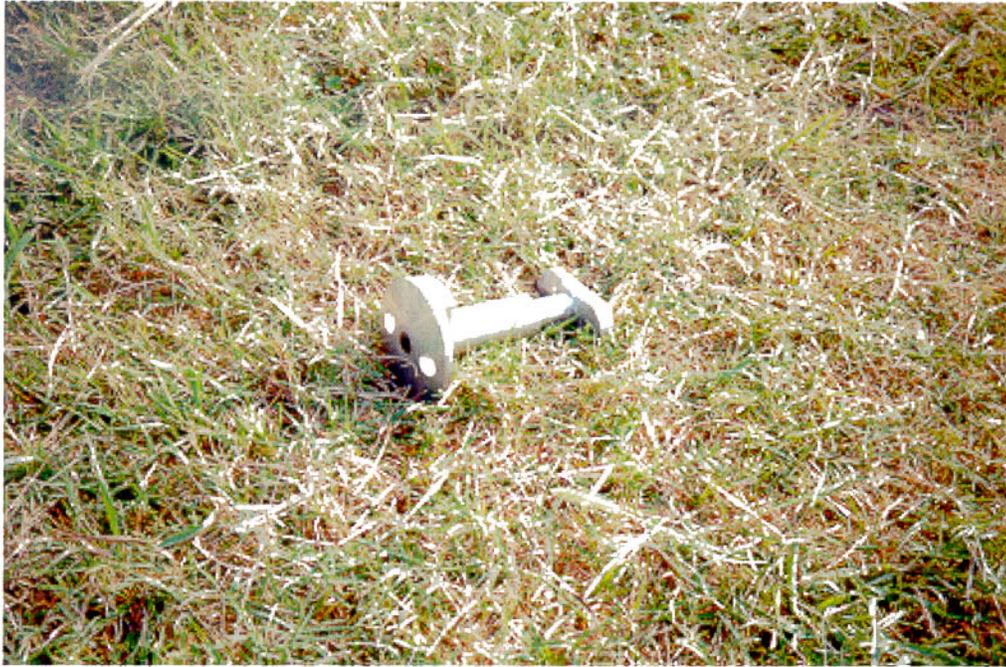
Photo 33. View of DURA-BASE pin connector

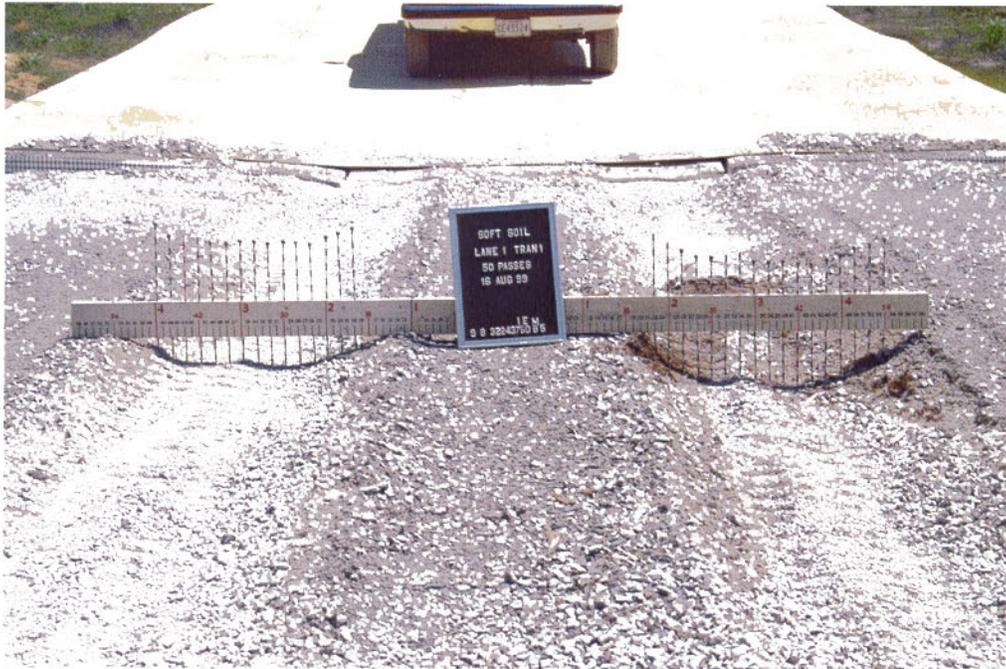
Photo 37. Ruts (2 1/2 in. deep) in Lane 1-Transition 1 after 50 truck passes

Initial traffic across Transition 1 produced slight rutting. The first item to require maintenance was Item 1. This item had two connector pins (with plastic center plugs) on the fiberglass mats to disconnect from the panels after 25 passes. These connector pins were replaced and traffic was continued. After 50 passes, significant rutting of Transition 1 continued to increase. Photo 37 illustrates the rutting of Transition 1. Also at the 50-pass level, water was pumped into the Lane 2 area. Pipes in the dike were lowered, and water entered the Lane 1 area. Water was added to maintain low subgrade strengths. The increased water level caused the buoyancy of the foam blocks beneath the fiberglass mats in Item 1 to increase, and the foam/mat system began to undulate as the truck moved across the roadway system. This movement caused a pumping action in the sand layer and subgrade which forced the sand to move from beneath the foam blocks to the edge of the roadway (Photo 38). Traffic movements also caused the fiberglass mats to move from the roadway center line. After the mats were repositioned on

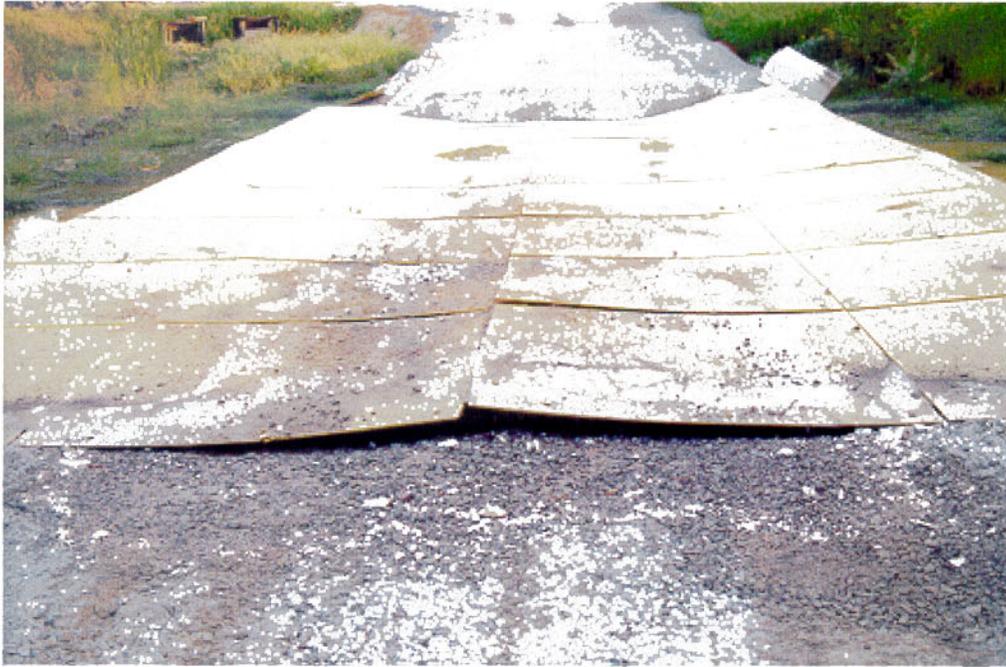
Photo 41. Condition of Lane 1-Item 1 after 150 truck passes

Also, at the 150-truck pass level, the geofoam/fiberglass mat system (Item 1) was considered unsafe. As the truck progressed across the roadway, a bow wave was noticed in front of the truck's front axle. The condition of the roadway system is shown in Photo 41. As shown, the center buoyant geofoam block was protruding upward since several of the connector pins were damaged and dislocated from the fiberglass mats (Photo 42). Twelve pins with plastic center plugs and seven with steel center plugs were dislocated. A close-up (Photo 43) of the roadway system shows that the center foam block was broken in two pieces, and other blocks on the same end were suspected to be broken. Repeated truck traffic had caused pumping beneath the foam blocks. Sand and subgrade material were forced toward the edges of the roadway, and the foam blocks along the roadway edges were tilted upward (Photo 44). Rutting of the roadway surface exceeded 3-in. (Photo 45).

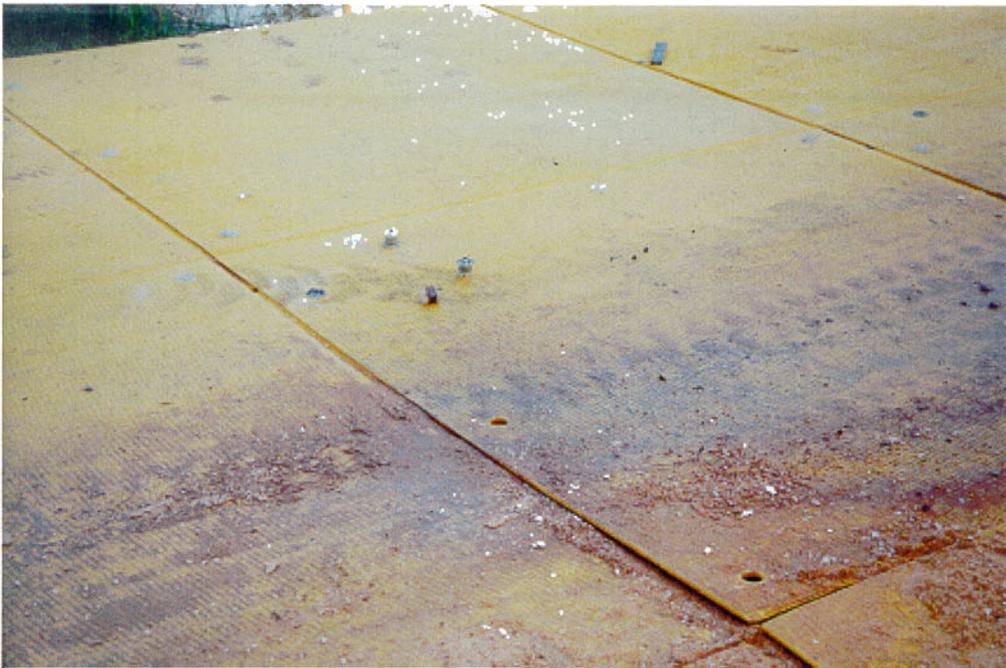
Photo 42. Dislocated connector pins on Lane 1-Item 1 after 150 truck passes

Item 1, they were anchored along the longitudinal edges with "T" anchors (a 6-in.-long flat bar welded to a 2-ft-long reinforcing rod with a 3/4-in. diameter). These anchors were driven through the fiberglass mats and into the foam blocks to prevent the mats from sliding on the blocks (Photo 39). After 50 passes, it was also noted that 12 connector pins along a transverse joint of the fiberglass mats in Item 1 had dislocated and were damaged. One-half of the pins contained plastic center plugs, and the other half contained steel plugs. New pins were placed on the fiberglass mats, and traffic was continued.

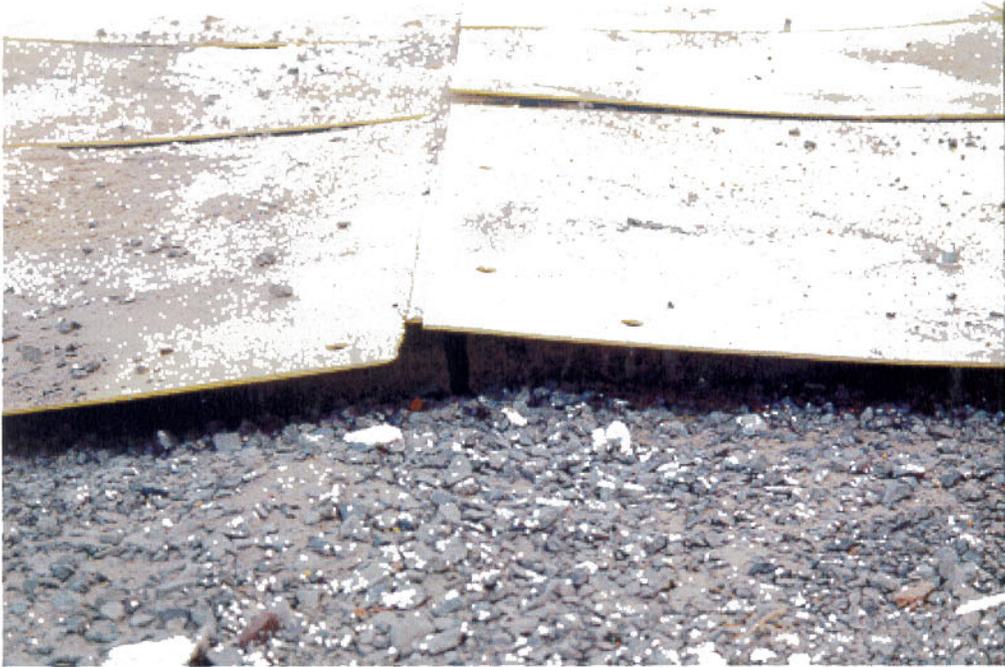
Photo 43. Close-up of broken center foam block, Lane 1-Item 1 after 150 truck passes

**Item 1.** Item 1 reached a permanent deformation of 3 in. after 50 truck passes and completely failed after 150 truck passes as a result of pumping of fines from beneath the roadway, failure of the geofoam in bending, and dislocation of fiberglass mat connector pins because of excessive flexing of the mat. The mat itself performed well and no panels were damaged.

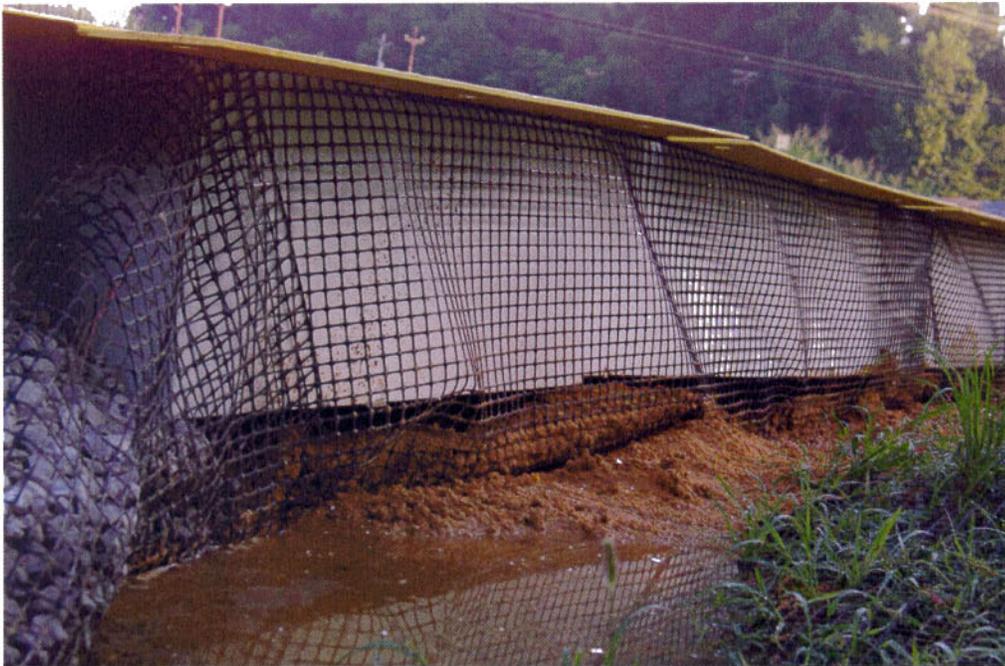
Photo 44. Condition of roadway edge, Lane 1-Item 1 after 150 truck passes

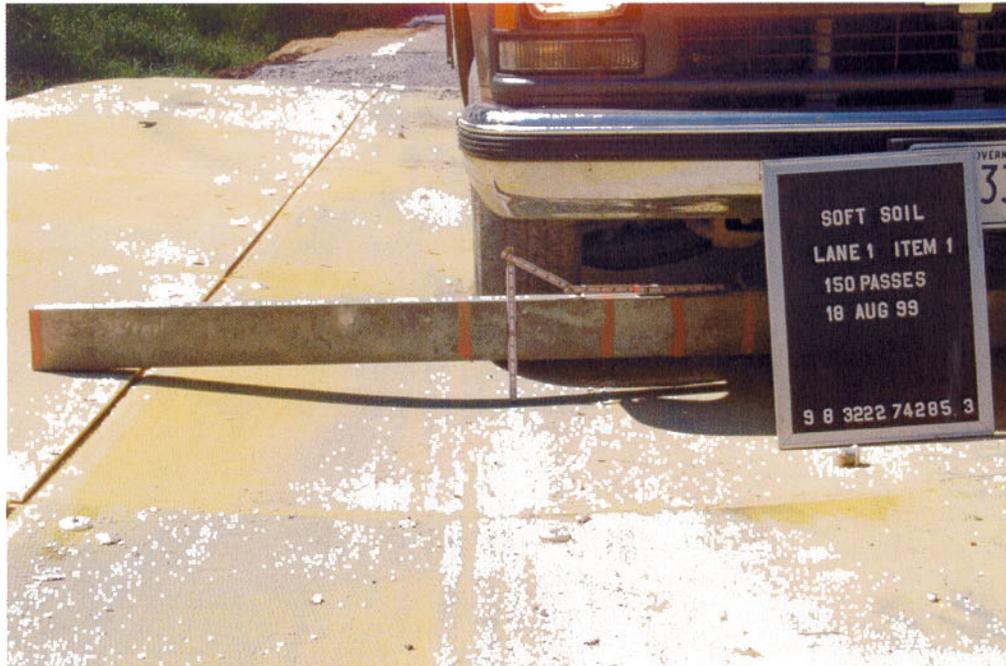
Photo 45. Rutting in excess of 3-in. on Lane 1-Item 1 after 150 truck passes

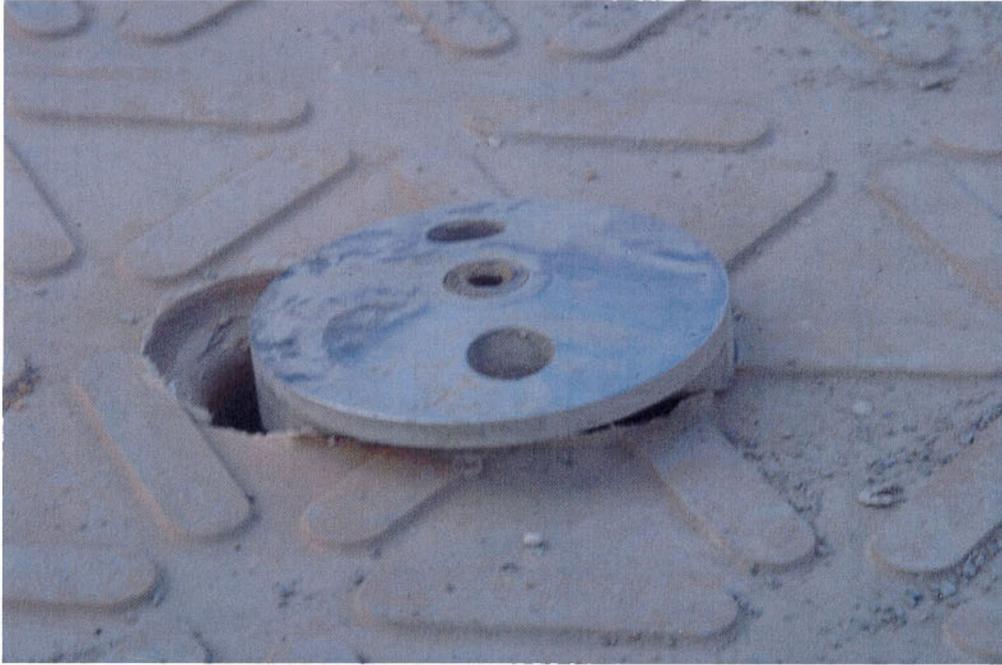
Photo 47. Loosened connector pin on Lane 1-Item 3 after 300 truck passes

Maintenance was performed on Item 5 after 300 truck passes. A loose timber from a SOLOCO wood mat was nailed in position, and traffic was continued on the roadway. After 300 truck passes, two metal connector pins in Item 3, which connected the top layer of plastic DURA-BASE mats, had loosened. The shoulder of the pin came out of the mat slot (Photo 47). This

condition remained and did not affect the performance of the plastic mat for the remainder of the 2,000 truck passes.

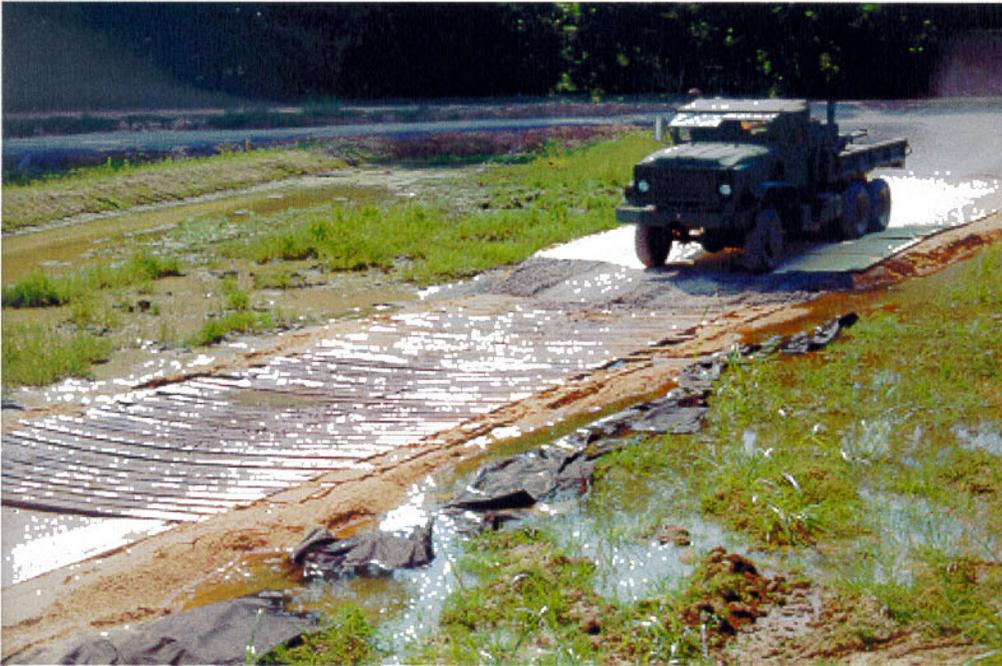
Photo 48. Water pumped into Lane 2 area after 50 truck passes

After 50 passes of repeated traffic, noticeable rutting was observed on Items 1, 2, 3, and 4. At the 50-pass level, water was pumped into this area (Photo 48). Pipes in the dike were lowered in order for the water to enter the Lane 1 area. Water was added to maintain low subgrade strengths. Rutting continued to increase on Items 1, 2, 3, and 4 after 100 truck passes. Photo 49 illustrates the rutting beneath the fiberglass mats in Item 4, which was also typical for the condition in Item 3. It was noted that one connector pin had dislocated from each of Items 3 and 4. Each pin contained a steel center plug. New pins were placed in the fiberglass mats, and traffic was continued.

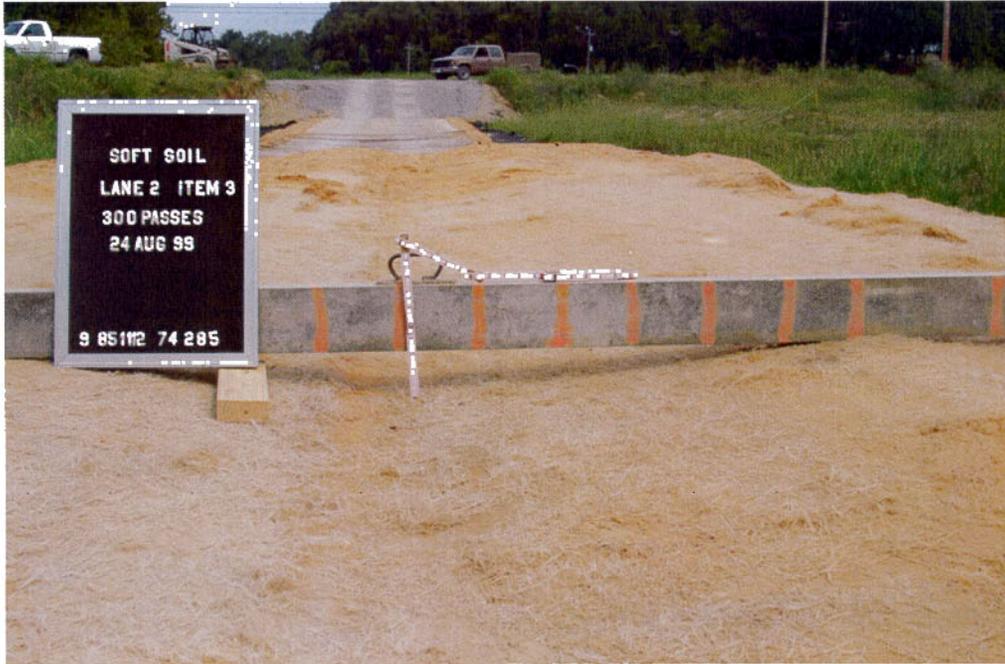
Photo 52. Rutting of fiber stabilized sand medium on Lane 2-Item 3 after 300 truck passes

Continuous truck passes caused rutting to increase beneath the fiberglass mats in Items 3 and 4. After 300 truck passes, connector pins became dislocated on several fiberglass mats where Item 3 transitioned into Item 2, and the fiberglass panels were free to move as traffic continued. Nine connector pins with plastic center plugs and seven pins with steel center plugs were dislocated. The condition of the fiberglass roadway is shown in Photo 51. Also at the 300 truck pass level, four connector pins in Item 4 were dislocated (two pins contained plastic center plugs and two pins contained steel plugs). Since the permanent deformation was 3 in. and the connector pins were beginning to dislocate, the fiberglass mats were removed from Items 3 and 4. There was no evidence of damage to the fiberglass panels. Rutting exceeded 3 in. on Item 3 (fiber-reinforced sand) and Item 4 (sand) as shown in Photos 52 and 53; respectively. DCP measurements revealed that the average strengths of Item 3 and Item 4 were 17 CBR and 12 CBR; respectively.

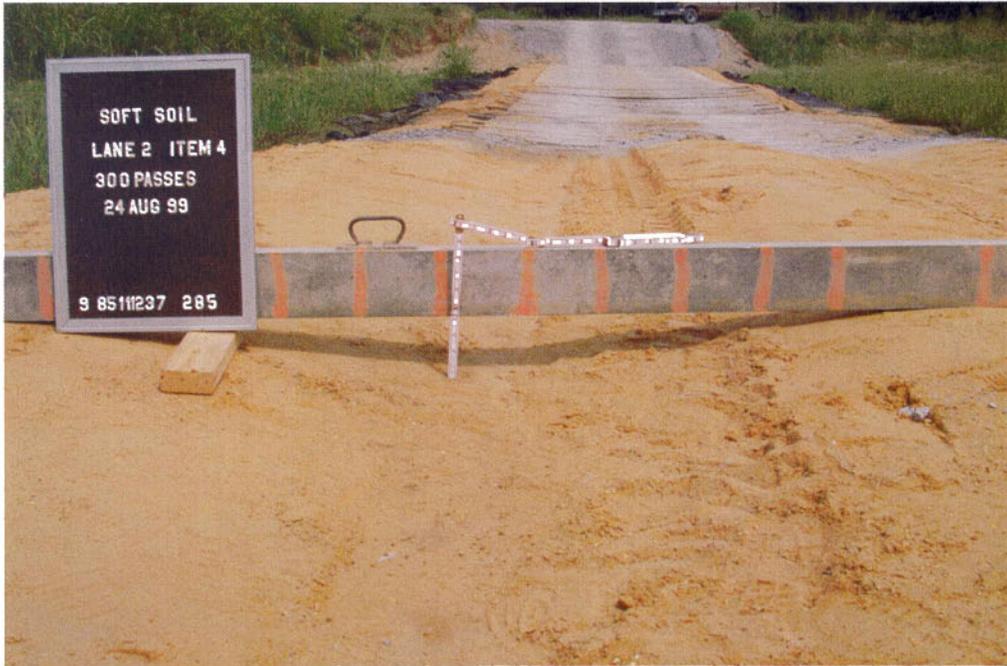
Photo 53. Rutting of sand medium on Lane 2-Item 4 after 300 truck passes

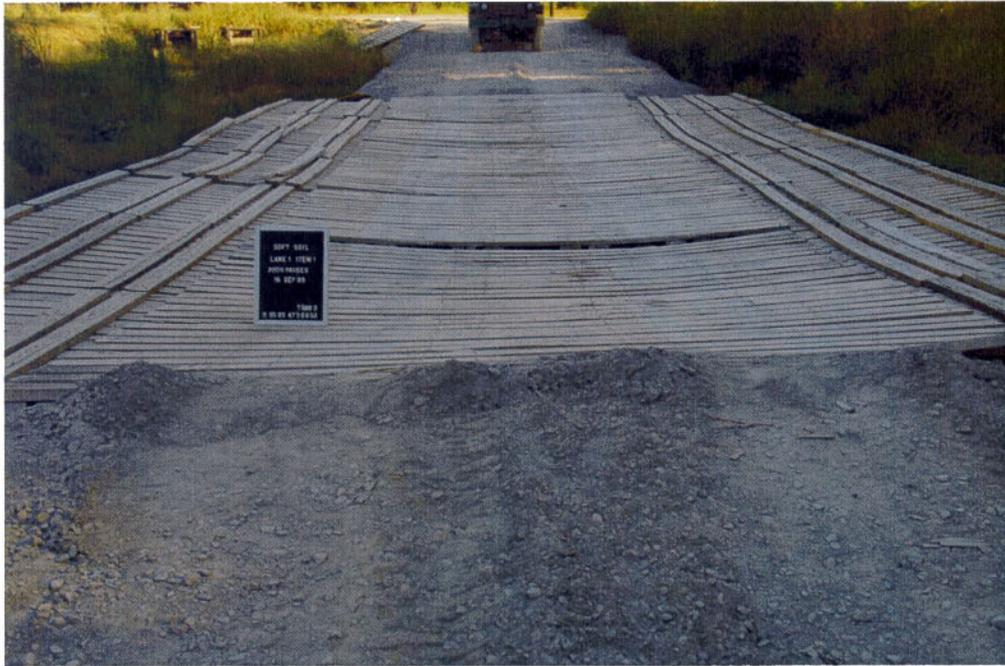
Photo 55. Posttraffic condition of Lane 1-Item 1 after 1,850 truck passes

roadway. After 150 truck passes, the roadway was modified in order to continue traffic. During the 150 passes, maintenance of the fiberglass-reinforced mats included the replacement of 33 connector pins. The modified roadway system, Uni-Mat panels placed over the initial system, provided an adequate roadway for 1,850 truck passes. However, deformation measurements were extremely high and the roadway system floated. Photo 55 shows the posttraffic condition of the modified roadway. The roadway surface was concave shaped in both longitudinal and transverse directions. Most of the sand leveling layer beneath the blocks pumped to the edges of the roadway as illustrated in Photo 56. After all mats were removed from the geofoam medium, 11 of the 13 geofoam blocks along the center of the item were broken in two pieces (Photo 57). The geofoam blocks did not conform to the subgrade deformation and voids without breaking and failed in bending. Posttraffic DCP measurements revealed that the average subgrade strength was 0.1 CBR.

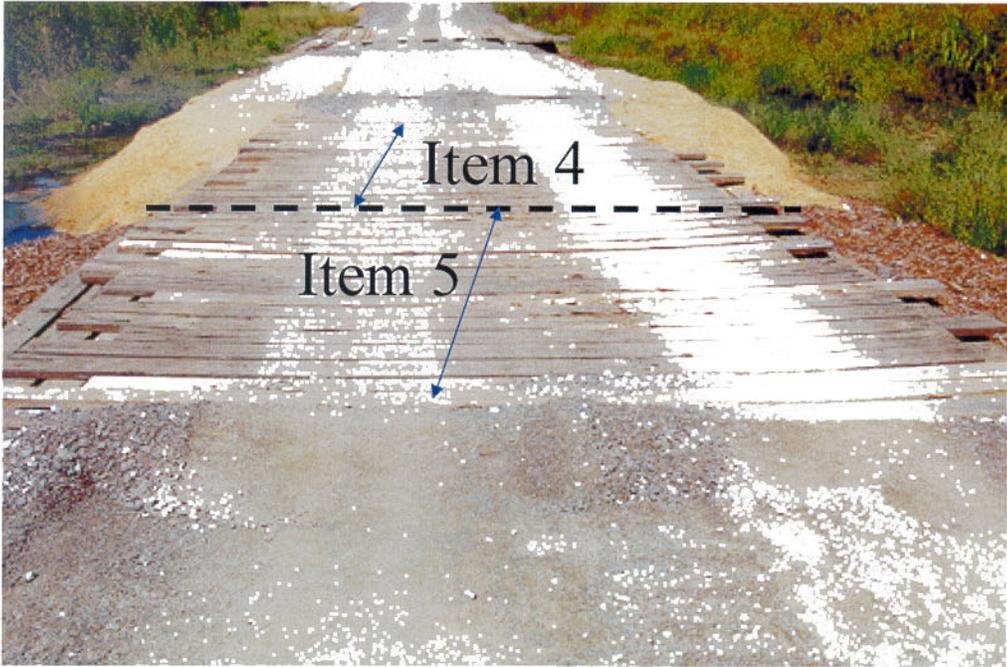
Photo 59. Posttraffic condition of Lane 1-Items 4 and 5 after 2,000 truck passes

**Lane 1-Items 4 and 5.** The posttraffic condition of Items 4 and 5 is shown in Photo 59. Both the SOLOCO wood mat placed over a sand medium (Item 4) and SOLOCO wood mat placed over a wood chip medium (Item 5) performed well throughout the application of 2,000 truck passes. The only maintenance occurred after 300 truck passes and a loose timber was nailed in position on Item 5. Posttraffic DCP measurements revealed that the average strengths on Item 4 (sand medium) and Item 5 (wood chip medium) were 6 and 8 CBR, respectively.

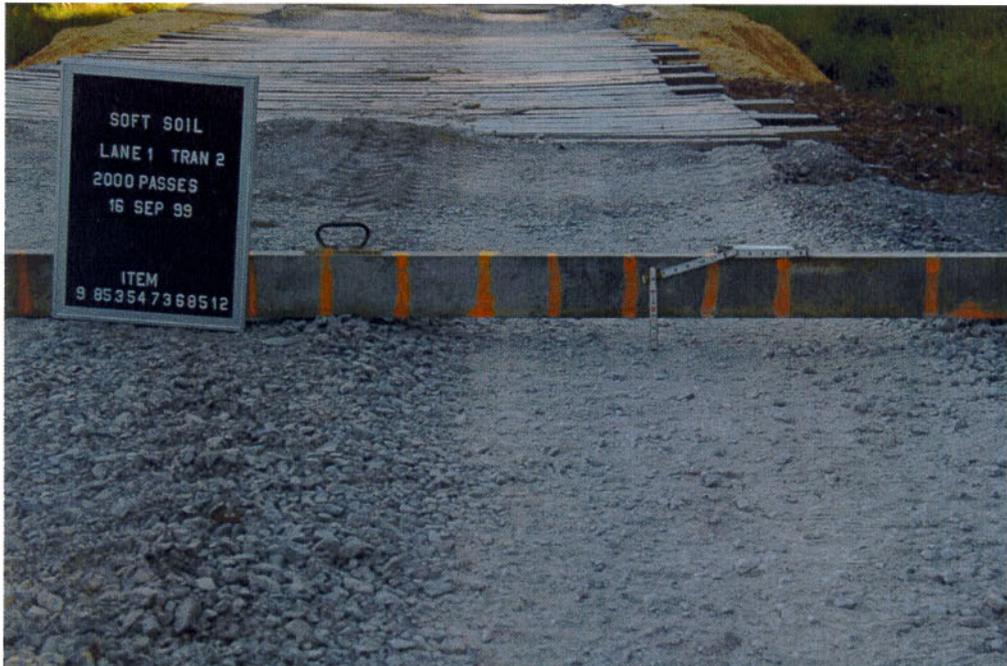
Photo 60. Posttraffic condition of Lane 1-Transition 2 after 2,000 truck passes

**Lane 1-Transition 2.** Photo 60 shows the posttraffic condition of the limestone surfacing placed over a geogrid and wood chip medium after 2,000 truck passes. Cumulative rutting occurred in the truck wheel paths; however, the roadway system provided adequate support for the applied traffic. The average strength of the limestone and wood chip layers at the conclusion of traffic were 67 and 13 CBR, respectively.

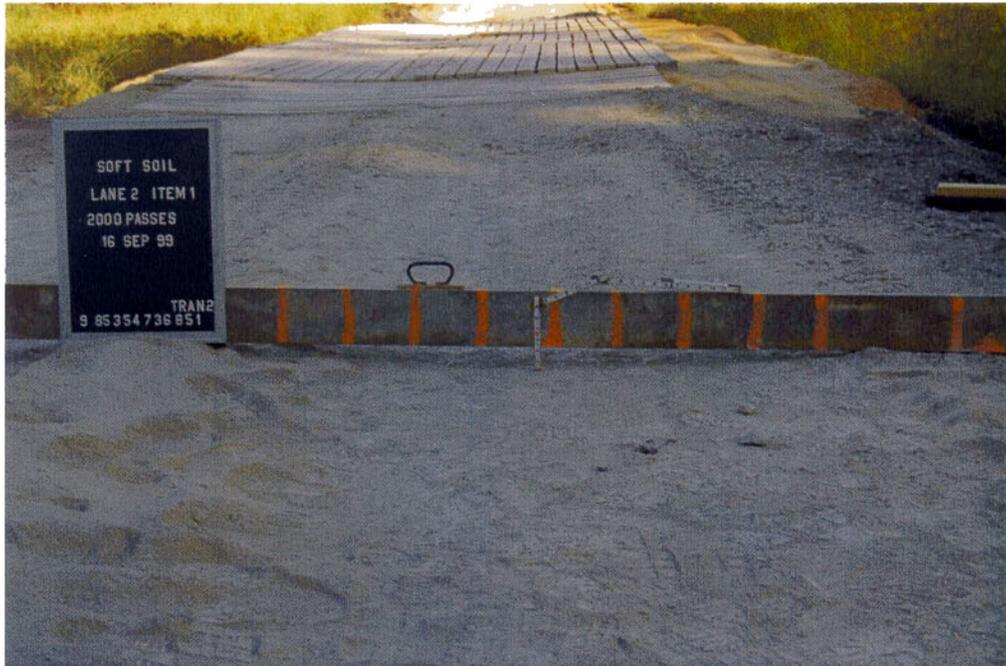
Photo 61. Posttraffic condition of Lane 2-Item 1 after 2,000 truck passes

**Lane 2-Item 1.** The posttraffic condition of the limestone surfacing placed over geogrid and geotextile is shown in Photo 61. Cumulative rutting occurred in the truck wheel paths; however, the roadway system provided

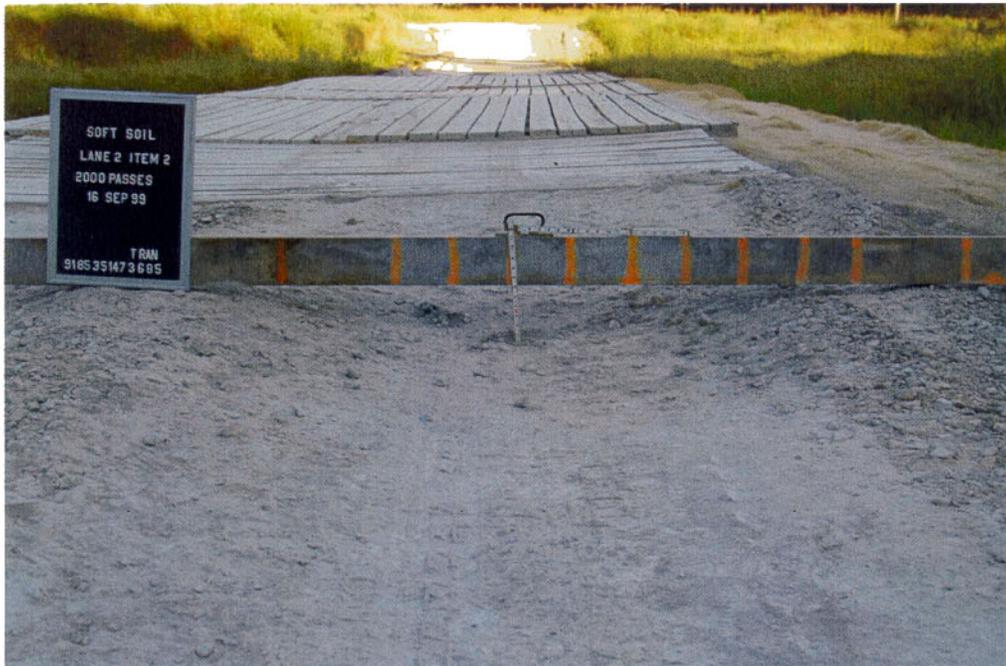
Photo 62. Posttraffic condition of Lane 2-Item 2 after 2,000 truck passes

**Lane 2-Item 2.** Photo 62 illustrates the post traffic condition of the roadway system (limestone surfacing placed on ECM material and geotextile) after 2,000 truck passes. Permanent deformation exceeded 3.5 in. after 150 truck passes, and deformation continued to increase as additional traffic was applied.

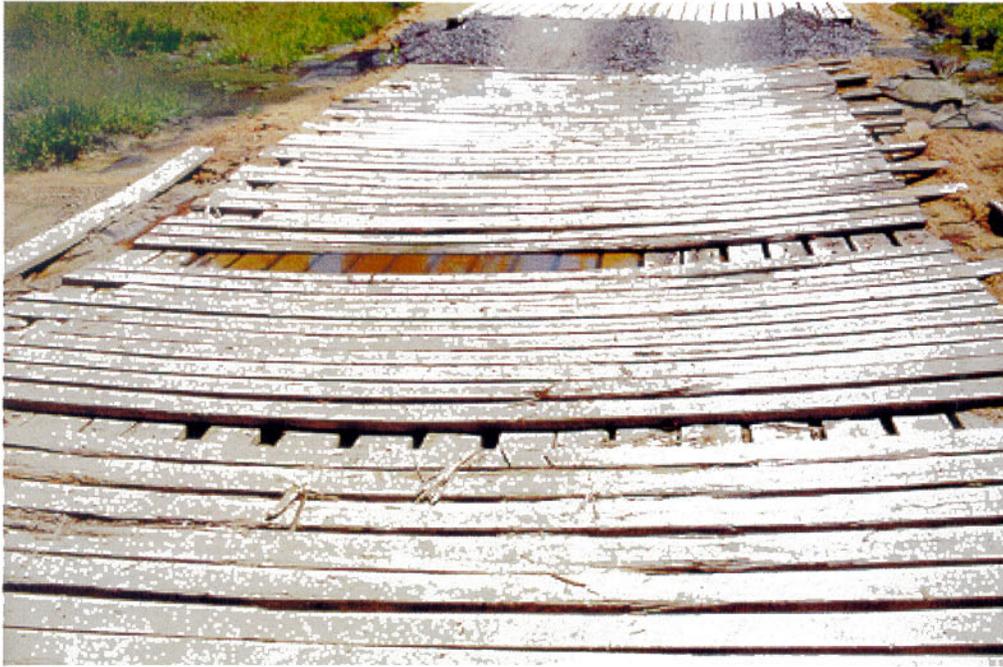
Photo 63. Posttraffic condition of Lane 2-Item 5 after 2,000 truck passes

**Lane 2-Item 5.** Photo 63 shows the post traffic condition of the roadway system (SOLOCO wood mat placed on geotextile) after 2,000 truck passes. The roadway system provided adequate structural support for the applied truck traffic. Four timbers required maintenance throughout 2,000 truck passes.

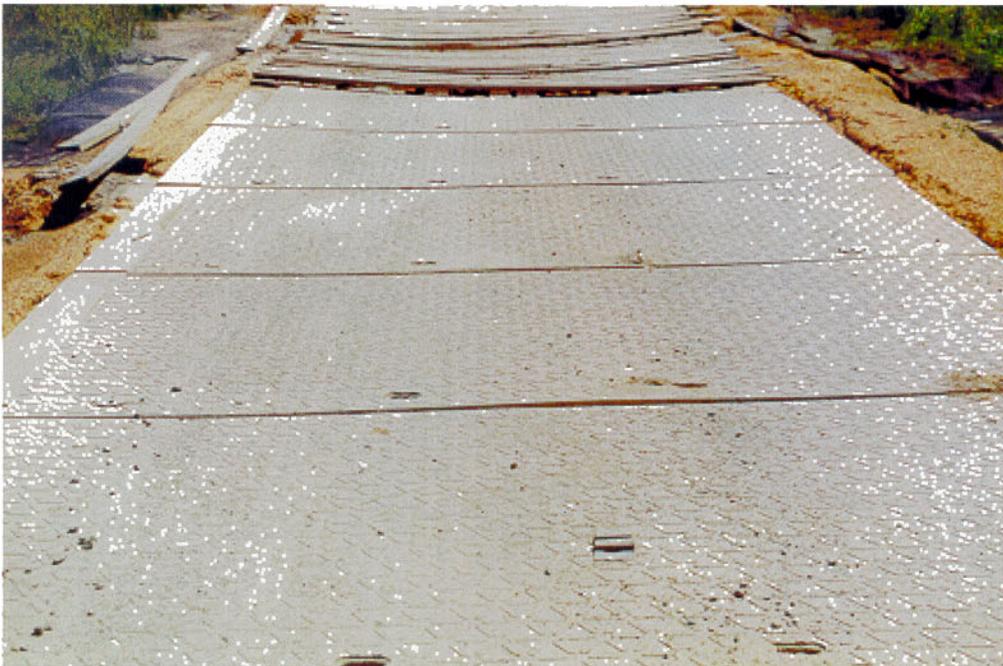
Photo 64. Posttraffic condition of Lane 2-Item 6 after 2,000 truck passes

**Lane 2-Item 6.** Photo 64 illustrates the post traffic condition of the plastic DURA-BASE mat placed on geotextile after 2,000 truck passes. The roadway system provided excellent structural support for the truck traffic.
